Home Inspection Report

1000 Main St.
AnyTown, Cape Cod, MA

Prepared By: Ken Amelin

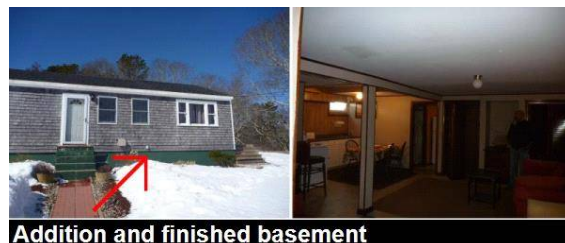
Analysis: A building permit and approvals by local authorities is required for work of this type.

Addition and finished basement

Recommendation: You should ask the owner if a building permit was issued for the work or you may check with the town hall for your record and safety.

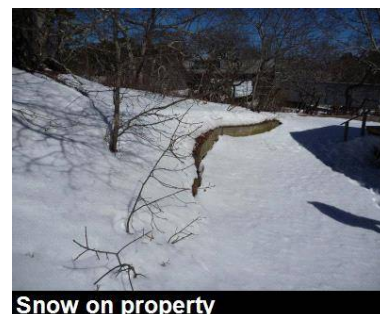
Observation: SNOW cover on the lot at time of inspection prevented a complete evaluation of the grading/drainage along the foundation.

Analysis: True drainage conditions and its impact on the home are concealed by the snow and undetermined.

Snow on property

Recommendation: The grading and drainage along the foundation and its impact on the home should be evaluated during the first available thaw and prior to purchase. You should ask the owner about any adverse conditions that may exist for your record.

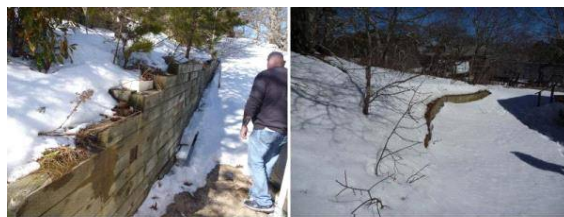
Retaining walls, PT wall greater than 4 ft

Observation: A recently constructed retaining wall is greater than 4 feet high.

Recommendation: You should ask the owner for a copy of the permit or check with the town for your information and record.

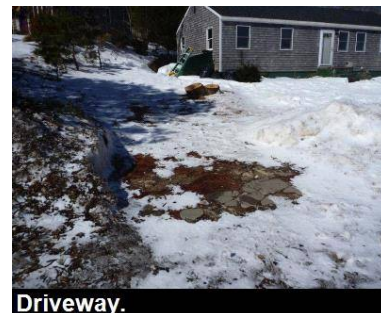
Analysis: Earth or sand driveways do NOT conform with modern construction practices and will suffer from seasonal problems such as mud, erosion, drainage problems etc.

Driveway.

Recommendation: Optional updating to asphalt or crushed stone with compacted base is advised.

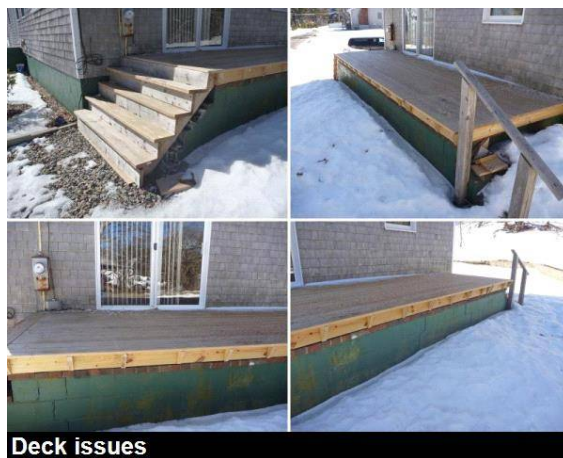
Observation: There are cracks in the foundation blocks supporting the deck flooring that are connected together forming a step appearance.

Analysis: Step type cracks indicate potential footing settlement. Often faulty drainage control and years of roof or surface water drainage along a foundation can erode some of the compacted fill beneath a footing, causing the footing to settle under load. The footing settlement is reflected upward into the foundation and has weakened the support structure.

Observation: The masonry support system (old patio) was built against siding, **Observation:** Guard rail less than 36 inch minimum.

Analysis: **SAFETY WARNING - potential for personal injury.**

Analysis: This condition allows water to contact siding. Eventually, the siding will decay due to contact with soil and water. This conditions also attracts wood destroying insects.

Recommendation: These cracks have weakened the structure and will continue to deteriorate and settle. Replacement is recommended. You should have the area of concern reappraised by a foundation contractor or structural engineer prior to commitment.

Recommendation: Elevate railing to 36 inch min. standard for safety. g. The siding extends below the masonry.

Recommendation: Eventually siding repair will be required. At that time you should consider improving the clearance between the siding and patio. You should contact a pest control company for treatment to prevent wood destroying insect infestation. (note: the structural members in the crawlspace were not accessible for view and there may be hidden damage not documented in this report. - Further evaluation advised)

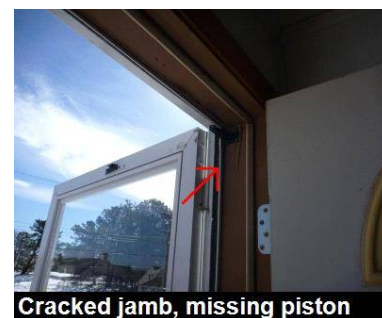
Broken Jamb at piston connection.

Analysis: I suspect the door was forced open by wind or other force. Repair is required.

Missing or defective piston closer noted.

Cracked jamb, missing piston

Recommendation: Contact a licensed carpenter for repairs.

Recommendation: Repair.

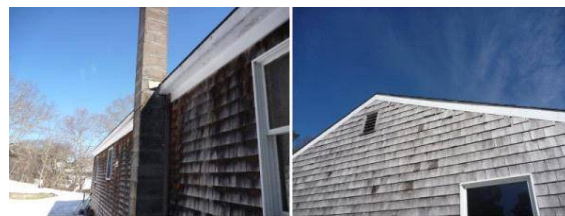
Observation: Cedar siding material had the following defects:
Loose siding shingles along rake edge trim boards along roof.

Observation: Areas of curled and cracked cedar siding are visible at rear..

Analysis: This indicates that the material is nearing end of lifespan. Siding with southern exposure tends to age at a faster rate.

Aged at rear, loose at rake board

Recommendation: Consult a siding contractor and request estimates for the repair or replacement of all defective siding & trim components.

Recommendation: Budget for siding replacement in those areas as required..

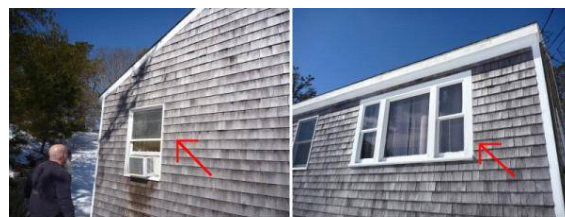
Analysis: Condensation between the panes of the thermal windows indicates a defect known as failed seals. Moisture has entered between the panes of glass and condensed causing the cloudy appearance. Failed seals reduce efficiency and thermal performance of the windows.

Failed seals, orig no storms

Observation: Original single glazed windows without storms. (bay window)

Recommendation: You should seek estimates for insulated glass replacement as this is the only way to restore clarity.

Recommendation: Replacement is advised. Seek estimates on modern thermal replacement units for improved energy efficiency and ease of maintenance.

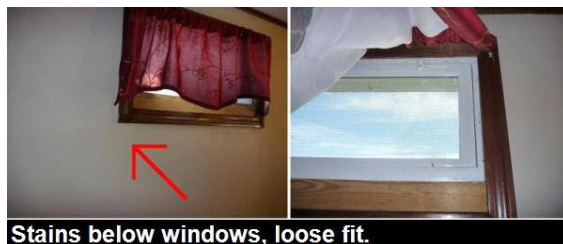
Observation: Stains are visible on the inside of the basement windows.

Analysis: Staining indicates that water infiltration has occurred at basement window(s). I suspect that the windows are level or lower than grade and water has leaked into the basement. Be advised that this condition promotes decay & insect infestation.

Stains below windows, loose fit.

Observation: Basement windows are not installed securely and are loose at opening.

Analysis: Poor workmanship, potential for leakage and a security risk.

Recommendation: I advise that the grade be lowered to provide a reasonable clearance, or that window wells be installed to reduce risk of water entry and prevent decay. Also recommend that roof runoff or gutter overspill be controlled as necessary. Contact a licensed carpenter or landscape contractor for further review and cost estimates for repairs as required.

Recommendation: Repairs are advised.

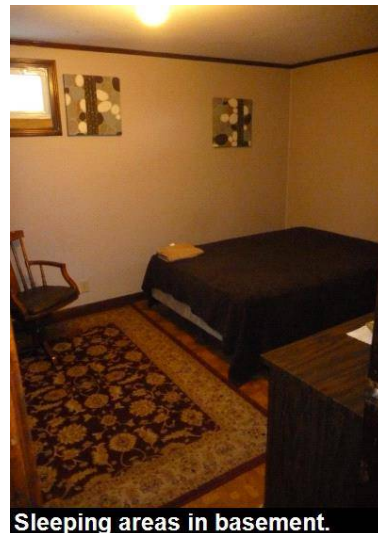
Observation: ESCAPE WINDOW SIZE QUESTIONED - the size of a window may be inadequate for emergency escape.

Analysis: The local building department can provide you with minimum escape window requirements. As a reference, all sleeping rooms and living areas are required to have at least one primary and secondary means of emergency egress - for example, a door and a window. An escape window must be easy to open; it must have a minimum area of 5.7 square feet, a minimum clear width of 20 inches; a minimum height of 24 inches; and a maximum sill height of 44 inches.

Sleeping areas in basement.

Recommendation: If any room within the home is to be used for sleeping or living and does not have a window that conforms to emergency escape dimensions, then I recommend that the room NOT be used for those purposes unless a suitable window is installed.

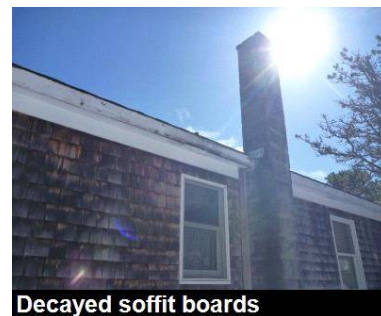
Observation: Areas of the wood fascia boards are decayed.

Analysis: Moisture damage is evident. Repair is needed.

Decayed soffit boards

Recommendation: Ask a carpenter to remove & replace all decayed materials as required. (Note: Repairs may reveal defects not documented in this report.)

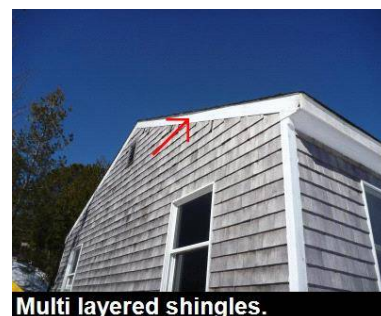
Observation: Areas of the roof are covered with multiple layers of shingles.

Analysis: Roofers will give a homeowner the option of applying a 2nd layer of shingles on the roof provided the underlying older layer is not deformed such that it would effect the 2nd layer. A 2nd layer of shingles is routine, but you should understand that the next routine roof replacement will be more costly as there will be additional charges for stripping the roof and disposing of the old materials. Also, the second layer of roofing is usually overlayed on top of the existing flashing. The existing flashing will continue to age and may not have the same life as the second roofing layer.

Multi layered shingles.

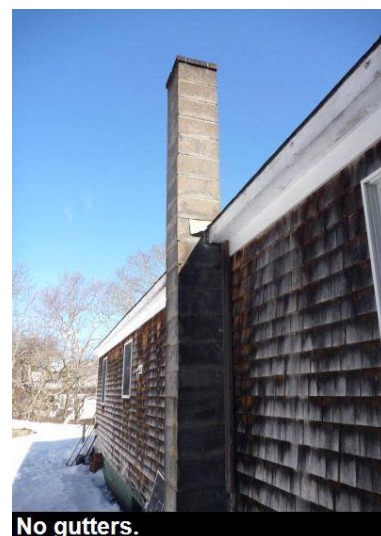
Analysis: Gutters are advised for all sloped roofs to control roof drainage. Without gutters, constant water fall from the roof may cause the following problems: moisture damage to all lower wood components, early paint failure, wet basement problems, soil erosion and ice hazards.

No gutters.

Recommendation: I advise that you hire a contractor to install seamless aluminum gutters at all sloped roof areas.

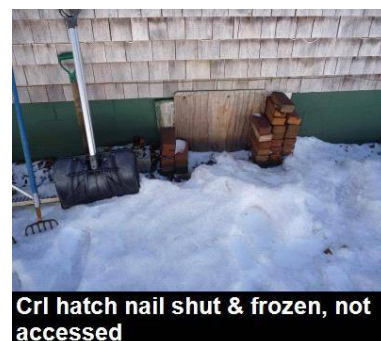
Analysis: Conditions within the crawl space are undetermined. Hidden problems could exist.

Crl hatch nail shut & frozen, not accessed

Recommendation: With the owner's permission, the sealed hatch should be opened and the entire crawl space inspected prior to commitment.

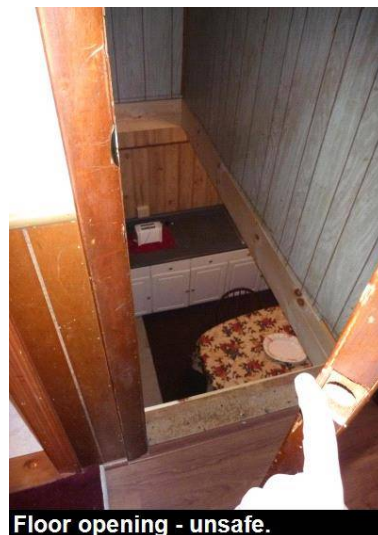
Analysis: The unprotected opening is UNSAFE as it can cause a personal injury.

Floor opening - unsafe.

Recommendation: I advise that you secure the door during construction of stairs and discuss the materials and specification of the planned stairs and schedule with the owner.

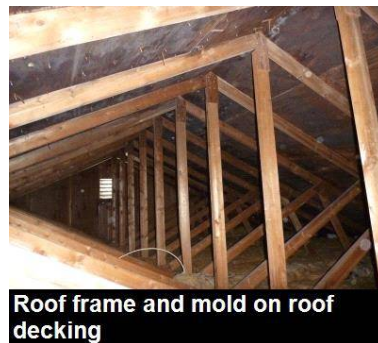
Roof frame and mold on roof decking

Recommendation: The moisture generators within the home need to be reduced &/or ventilation improvements made to reduce mildew.

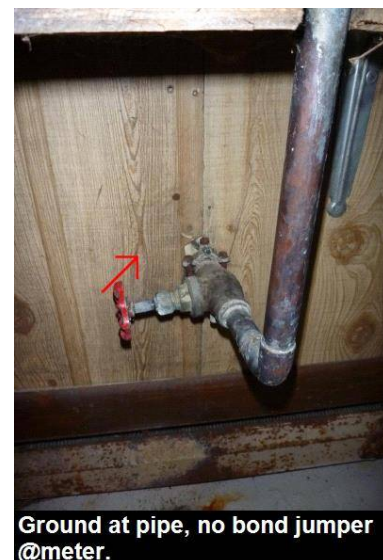
Ground at pipe, no bond jumper @meter.

Recommendation: Hire an electrician to install a jumper ground cable at the water meter for greater safety and to conform with modern ground/bond requirements.

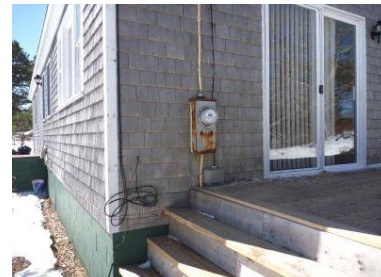
Meter box rusted.

Recommendation: I advise that the connections at the top and bottom of the box be sealed with dux-seal to keep water out and that the box be painted to inhibit rust.

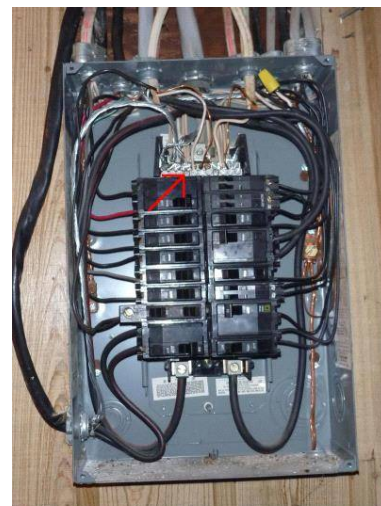
Ground @ neutral, no room expansion.

Recommendation: Equipment upgrading is advised. Contact a licensed electrician for alternatives and cost estimates prior to purchase.

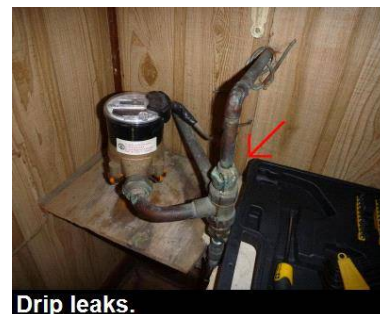
Analysis: Repair is needed.

Drip leaks.

Recommendation: Notify the water department and request further evaluation to determine the jurisdiction of needed repairs.

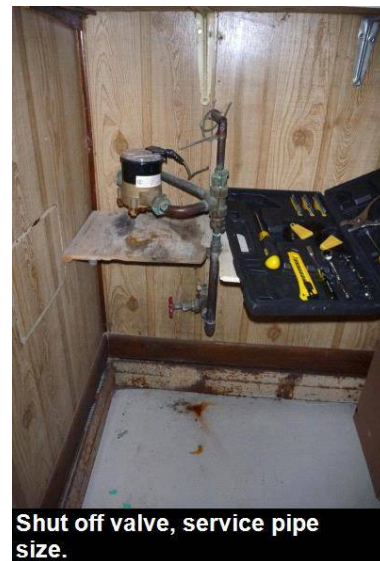
Shut off valve, service pipe size.

Recommendation: Monitor the piping for corrosion repair and leaks. Repair as required.

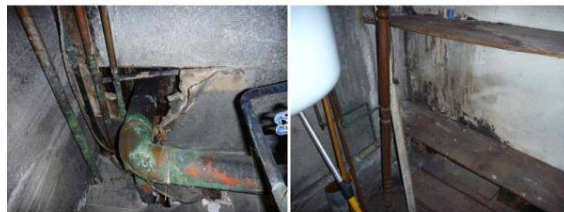
Plumbing issues.

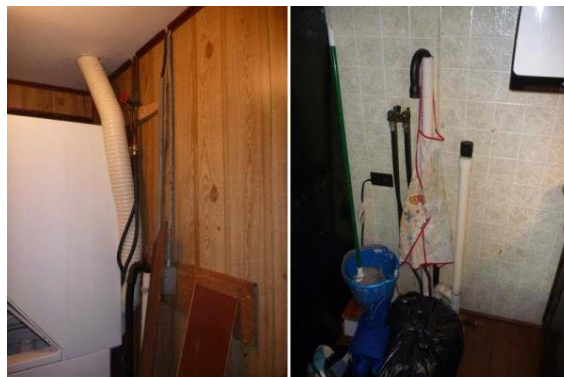
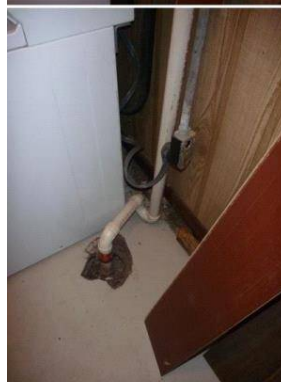
Laundry connections , amateur work.

Recommendation: Be advised that new Massachusetts Title V regulations now prohibit separate gray water drains. For your protection, you should check the required Title V inspection report to see if any gray water drains were located and evaluated.

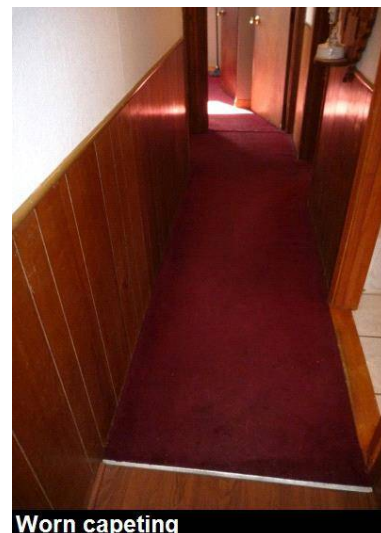
Worn capeting

Recommendation: Replacement.

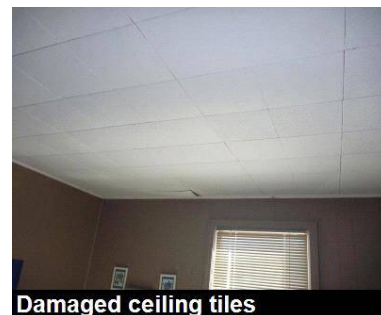
Damaged ceiling tiles

Seal ceiling stains with a product called stain-kills and repaint ceilings as required.

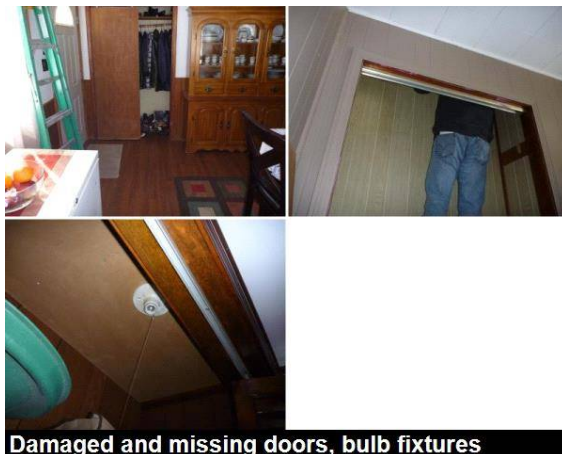
Damaged and missing doors, bulb fixtures

Recommendation: While no repairs are required, I recommend that you install a fluorescent bulb or new recessed light fixture for modern fire safety.

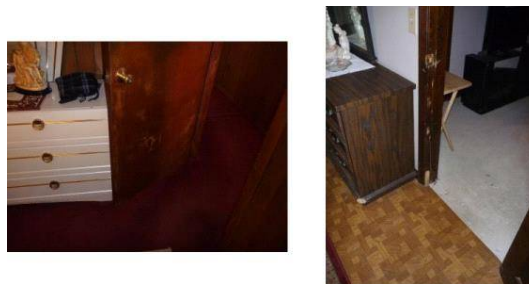
Damaged doors

Recommendation: You should more closely examine each interior door and replace as required.

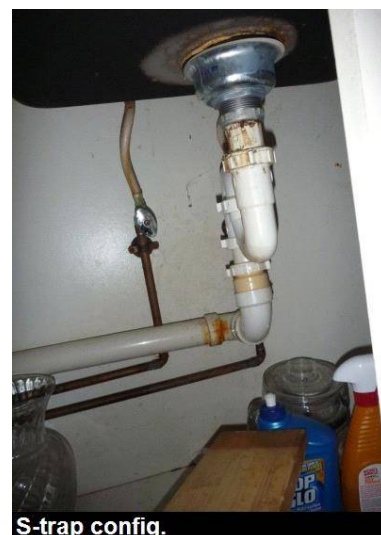
S-trap config.

Recommendation: No repair is required unless the fixture is worked on, then a modern P-shaped trap will be required. If any remodeling takes place, it will be necessary to update the waste piping by installing a P-shaped trap and re-vent connection.

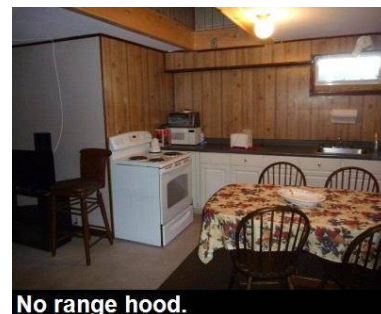
No range hood.

Recommendation: The installation of a range hood or fan is advised.

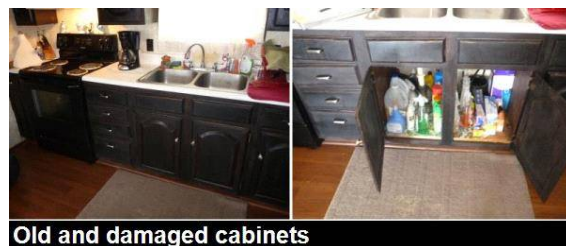
Old and damaged cabinets

Recommendation: I advise that you visit a kitchen cabinet contractor and review options for remodeling the room.

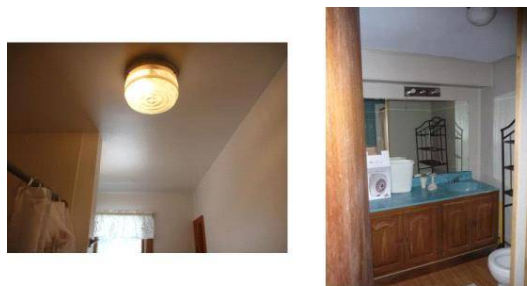
window, no ventilation

Recommendation: Contact a licensed contractor and install an exhaust fan as required.

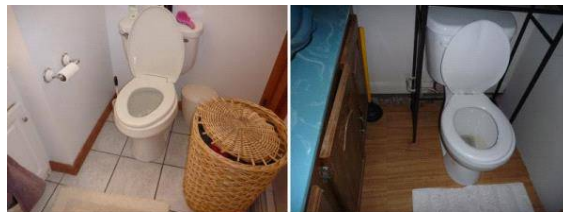
Loose toilet flanges.

Recommendation: Hire a plumber to secure the toilet to the floor and flange as required.

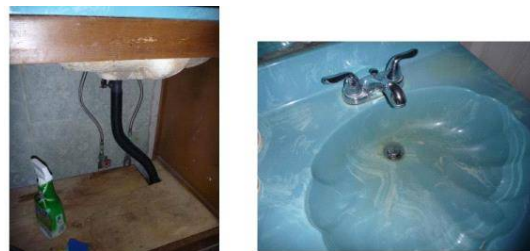
Bath sinks and drain.

Recommendation: Hire a plumber to replace the integrated counter top and sink.

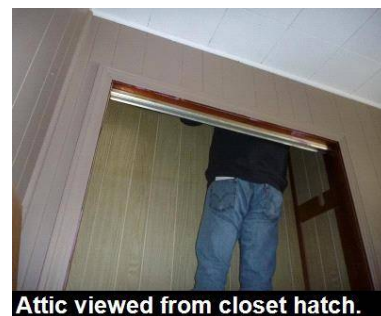
Attic viewed from closet hatch.

Recommendation: Further inspection suggested when access, clearances, walking surfaces or lighting are improve. (Note: Hatch covers should be weatherstripped & insulated to prevent heat loss.)

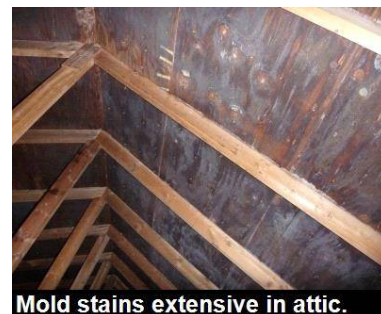
Mold stains extensive in attic.

Recommendation: Reduce the sources of moisture & increase attic ventilation.

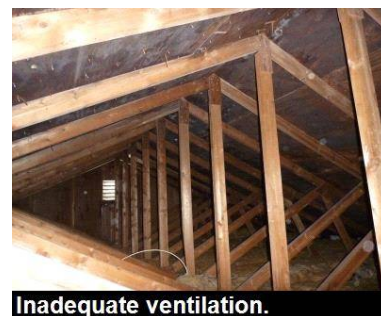
Inadequate ventilation.

Recommendation: Update the attic ventilation system now or at time of next scheduled roof replacement. **The installation of a modern ridge vent & soffit vent system is advised as the best means of ventilation.** (Attics with a ceiling vapor barrier should have a screened opening of at least 1 SF of free vent area for each 300 SF of ceiling space. Attics without a ceiling vapor barrier should have a screened opening of at least 1 SF for each 150 SF of ceiling area.)

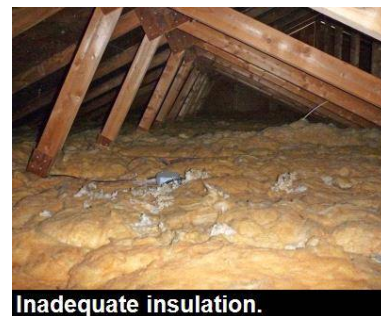
Inadequate insulation.

Recommendation: Have an energy audit performed and then consider updating the insulation in all applicable areas.
