Home Inspection Report

1000 Main St.
AnyTown, Cape Cod, MA

Prepared By: Ken Amelin

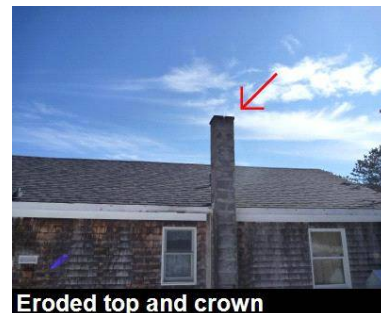
Analysis: Chimney repairs needed.

Recommendation: Ask a mason to provide an estimate for repointing the chimney as needed.

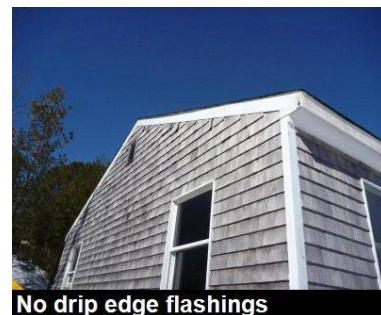
Analysis: Shingle manufacturers recommend that roof coverings be installed according to the directions printed on the bundle of shingles. As written in the directions on each bundle of shingles, non-corroding metal drip edge is recommended at all edges of the roof. Newer building regulations now require flashing at the rake edge trim boards to decrease the potential for wind driven rain leakage.

Recommendation: As repair is too destructive, I advise that the flashing be installed along all rake edge or gable trim boards at time of next roof replacement.

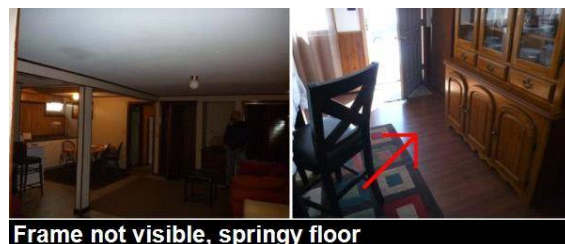
Analysis: The floor frame may be undersized, over spanned or decayed.

Recommendation: I advise that the floor frame be reinforced or stabilized as required to solve the problem. Consult a carpenter for reappraisal and cost estimates.

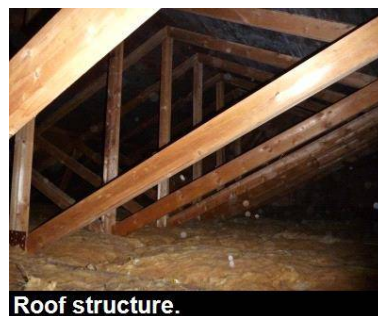
Roof structure.

**** FUNCTIONAL with EXCEPTIONS: Repair or Replacement Required.**

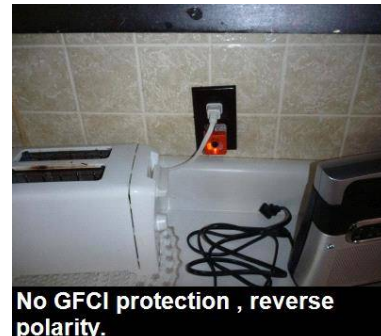
**** **UNSAFE: - Safety Repairs Required.**

Observation: A GFCI device is missing at: Outlets serving kitchen counters. Basement outlets. Exterior outlet.

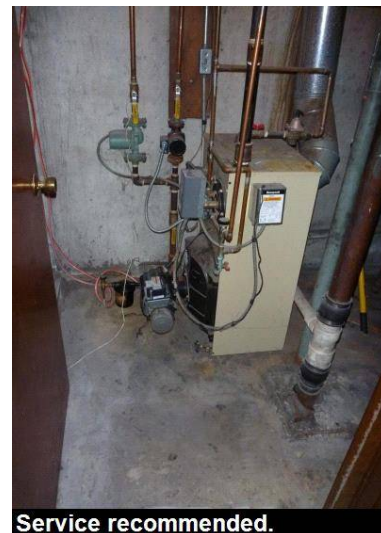
Analysis: The lack of maintenance tags may indicate postponed annual maintenance cleanings, tune-ups, parts replacement and safety inspection.

Recommendation: You should have the heating system serviced now, prior to occupancy and annually there after to establish a regular service schedule.

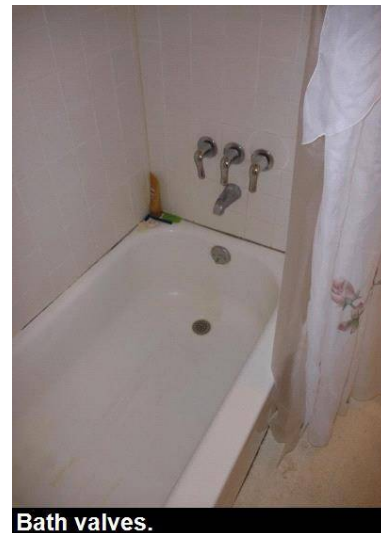
Analysis: Gaps could allow leakage & interior water damage.

Recommendation: Caulk tub / floor joint, tub / wall joint and faucet spout & handle as general maintenance.

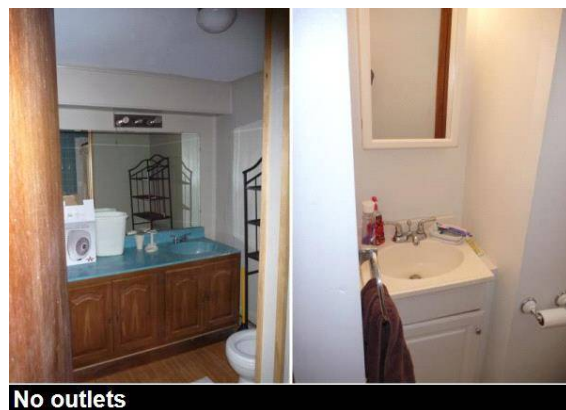
Analysis: The lack of an outlet will be inconvenient by modern standards.

Recommendation: A GFCI protected outlet installation is recommended for modern shock protection. Consult an electrician at your option.
